Eurocopter Fleet Safety Department  
Aéroport de Marseille Provence  
Marignane 13725

Subject: ANC08FA053

Pursuant to 49 Code of Federal Regulations 845.41, Eurocopter petitions the National Transportation Safety Board to reconsider its findings and determination of probable cause in the accident investigation resulting from the crash of a Eurocopter AS-350-B2 helicopter, which occurred on 15 April 2008, near Chickaloon, Alaska.

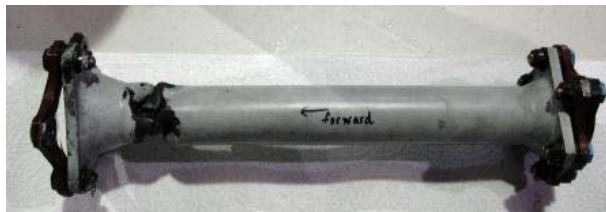
Figure 1

- The engine to main transmission drive shaft was found twisted and shortened (Figure 1), resulting in liberation of the splined (rear) end of the shaft for the engine output; engineering calculations performed by the Eurocopter design office revealed such damage would result from a torque event of at least 300 percent.

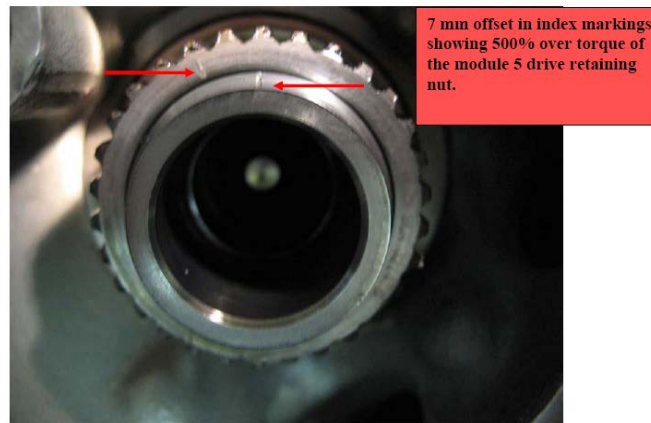
Figure 2

- The module 5 drive retaining nut in the engine contains an index mark (Figure 2) which was misaligned approximately seven millimeters as a result of the accident sequence; According to Turbomeca, the engine manufacturer, such misalignment would result from a torque event of approximately 500 percent.

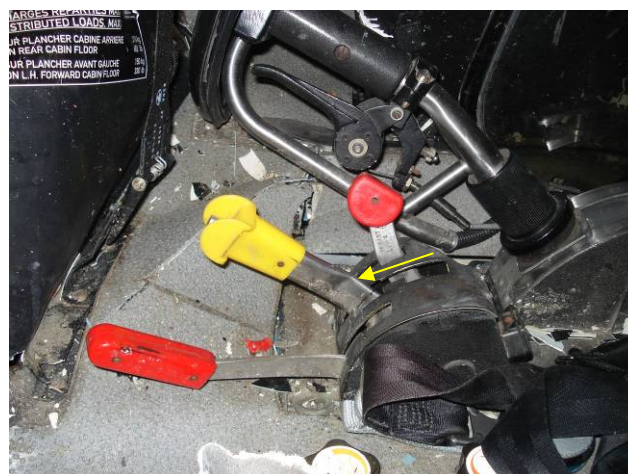
- The FFCL was found bent to the left, detent-side direction, indicating it sustained a significant impact force at some point during the accident sequence. Please see Figure 3 and refer to Appendix 1.

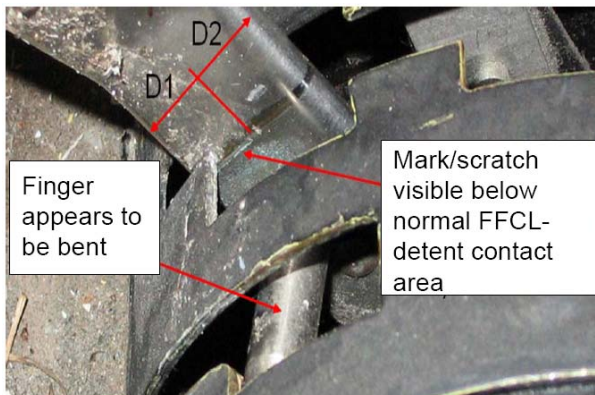
- There is no evidence to prove that the observed position of the FFCL above was the position at the time of the final impact.
- Figure 4 below shows a mark/scratch below the normal lever-detent contact area and deformation of the finger, which indicates that such damage would occur only as the result of a significant force on the FFCL in the detent direction great enough to create a differential movement relative to the quadrant, i.e. during impact.
- In addition, the length of this mark shows that the FFCL lever was not in the full emergency position when the damage occurred, as the distance D1 is equal to the distance D2 and shorter than D3 in Figure 5 (exemplar FFCL), which corresponds to the full emergency position.

- The damage observed on the FFCL could have resulted from the crash itself; the subsequent location of the FFCL could have been a result of a post crash action by the pilot or survivor, or a result of the wreckage recovery process.

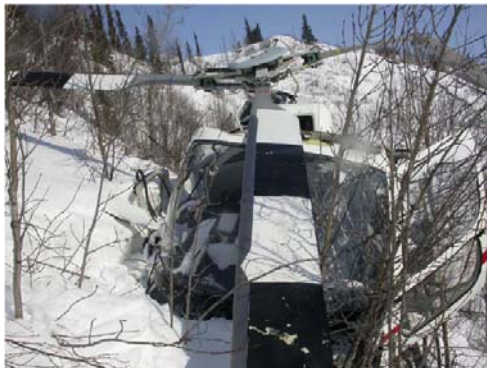
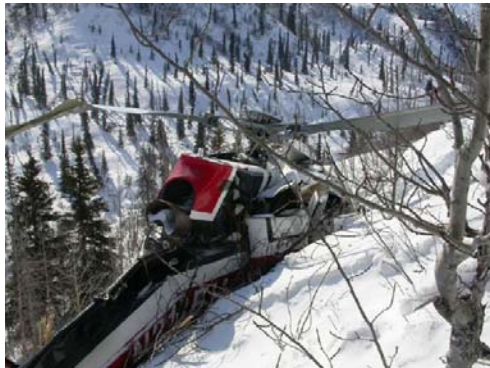
According to the NTSB Factual Report, the NTSB Investigator in Charge (IIC) and two other investigators returned to the site on June 4, 2008, nearly two months after the accident, to look for evidence of a main rotor blade strike, but found none. While Eurocopter appreciates the effort of the NTSB IIC, it is unlikely that evidence of a main rotor blade strike would remain, as the general accident area was covered in snow at the time of the accident (Figures 6 & 7).

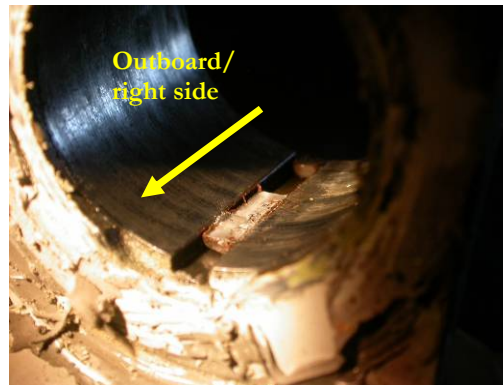
Figure 8

4. The tail rotor shaft key sheared inside the tail rotor hub, consistent with a high torque event in the direction of sudden tail rotor drive shaft acceleration when main gearbox drive shaft disengaged (Figure 8).

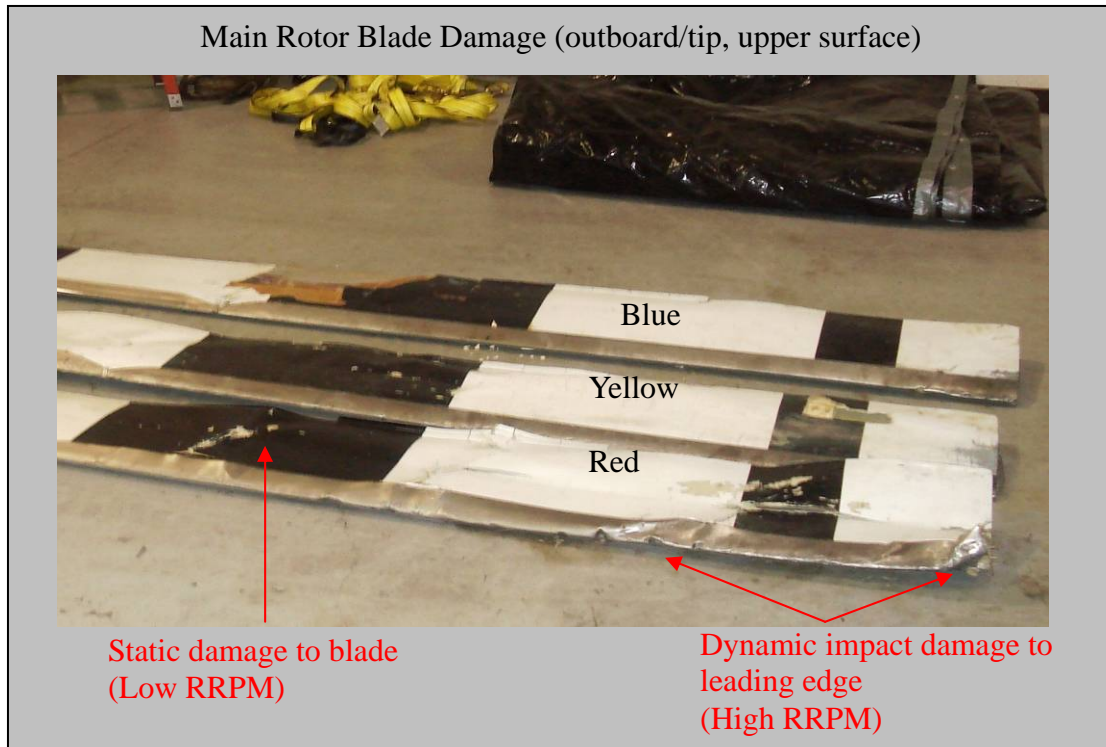
The main rotor blades exhibited static puncture damage, chord wise bending, and trailing edge splitting consistent with low to no main rotor RPM on final impact. Two of the three blades came to rest in willow bushes with unbroken branches on both sides. However, the Starflex main rotor hub and red main rotor blade leading edge exhibited damage consistent with a powered impact suggesting a main rotor impact occurred during flight, prior to the final impact. Please refer to Appendix 8.

5. The Starflex main rotor hub and red main rotor blade leading edge exhibited damage consistent with a powered impact suggesting a main rotor impact occurred during flight, prior to the final impact; however, there was also damage to the red main rotor blade consistent with a low rpm impact (static punctures and chord-wise bending) at the site. Please see to Figure 9 below and refer to Appendix 8 for additional information.

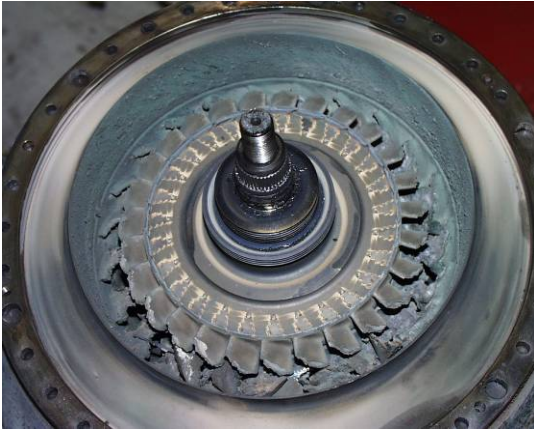
Figure 10

- First and second stage power turbine blades were 50 to 70 percent melted (Figure 10).
- No blade shedding occurred on the free turbine blades (Figure 11).
- No evidence of an overtorque was found on the Module M05 splined sleeve.
- Engine to MGB coupling shaft did not evidence any sign of torsion.

These findings indicate that the additional fuel flow resulting from a movement of the FFCL to the emergency range would result in overtemping to the point of degradation of the power turbine stages. However, a movement of the FFCL to the emergency range would not result in an overtorque or an in flight overspeed of the free turbine assembly consistent with the damage observed on Era Helicopters' AS350B2, S/N 3158. The lack of any engine overspeed damage in the earlier accident involving S/N 1317 with the intentional in-flight movement of the FFCL to the emergency range is substantial evidence that movement of the FFCL was not involved with the engine damage in this accident.
